***SITE ST012,
FORMER LIQUID FUELS
STORAGE AREA***

REMEDIAL ACTION

ST012 UPDATE

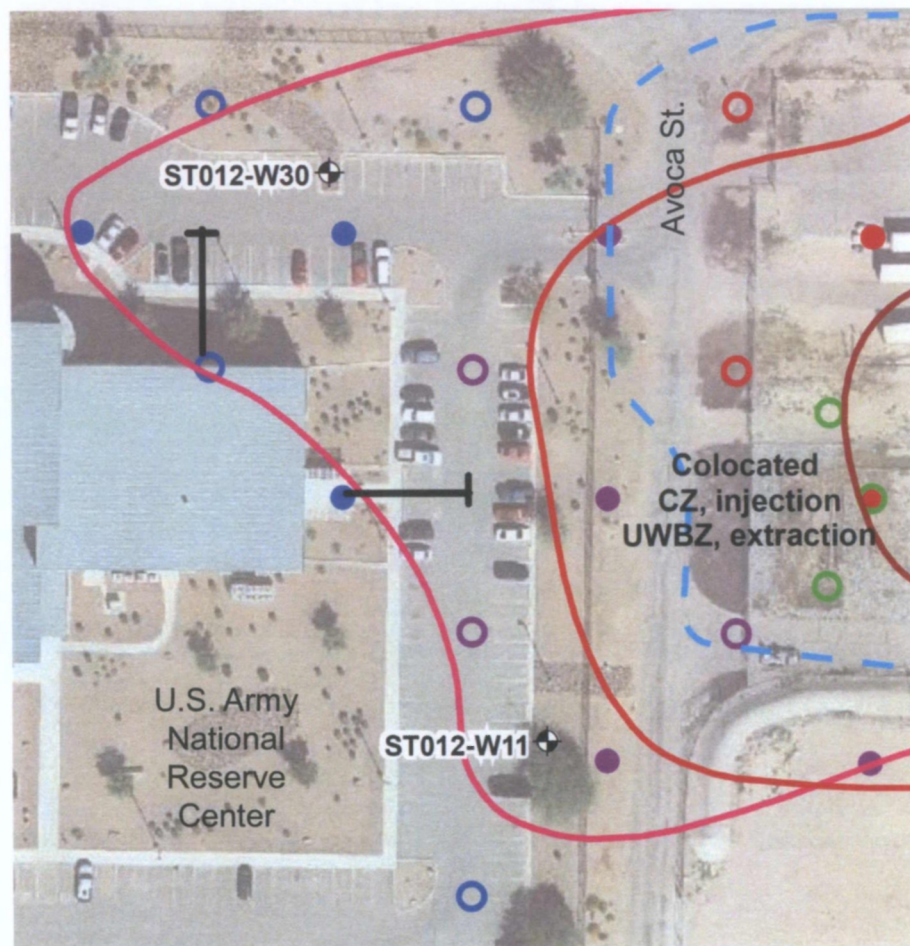
EBR field test Well locations in the western portion of the conceptual EBR well field

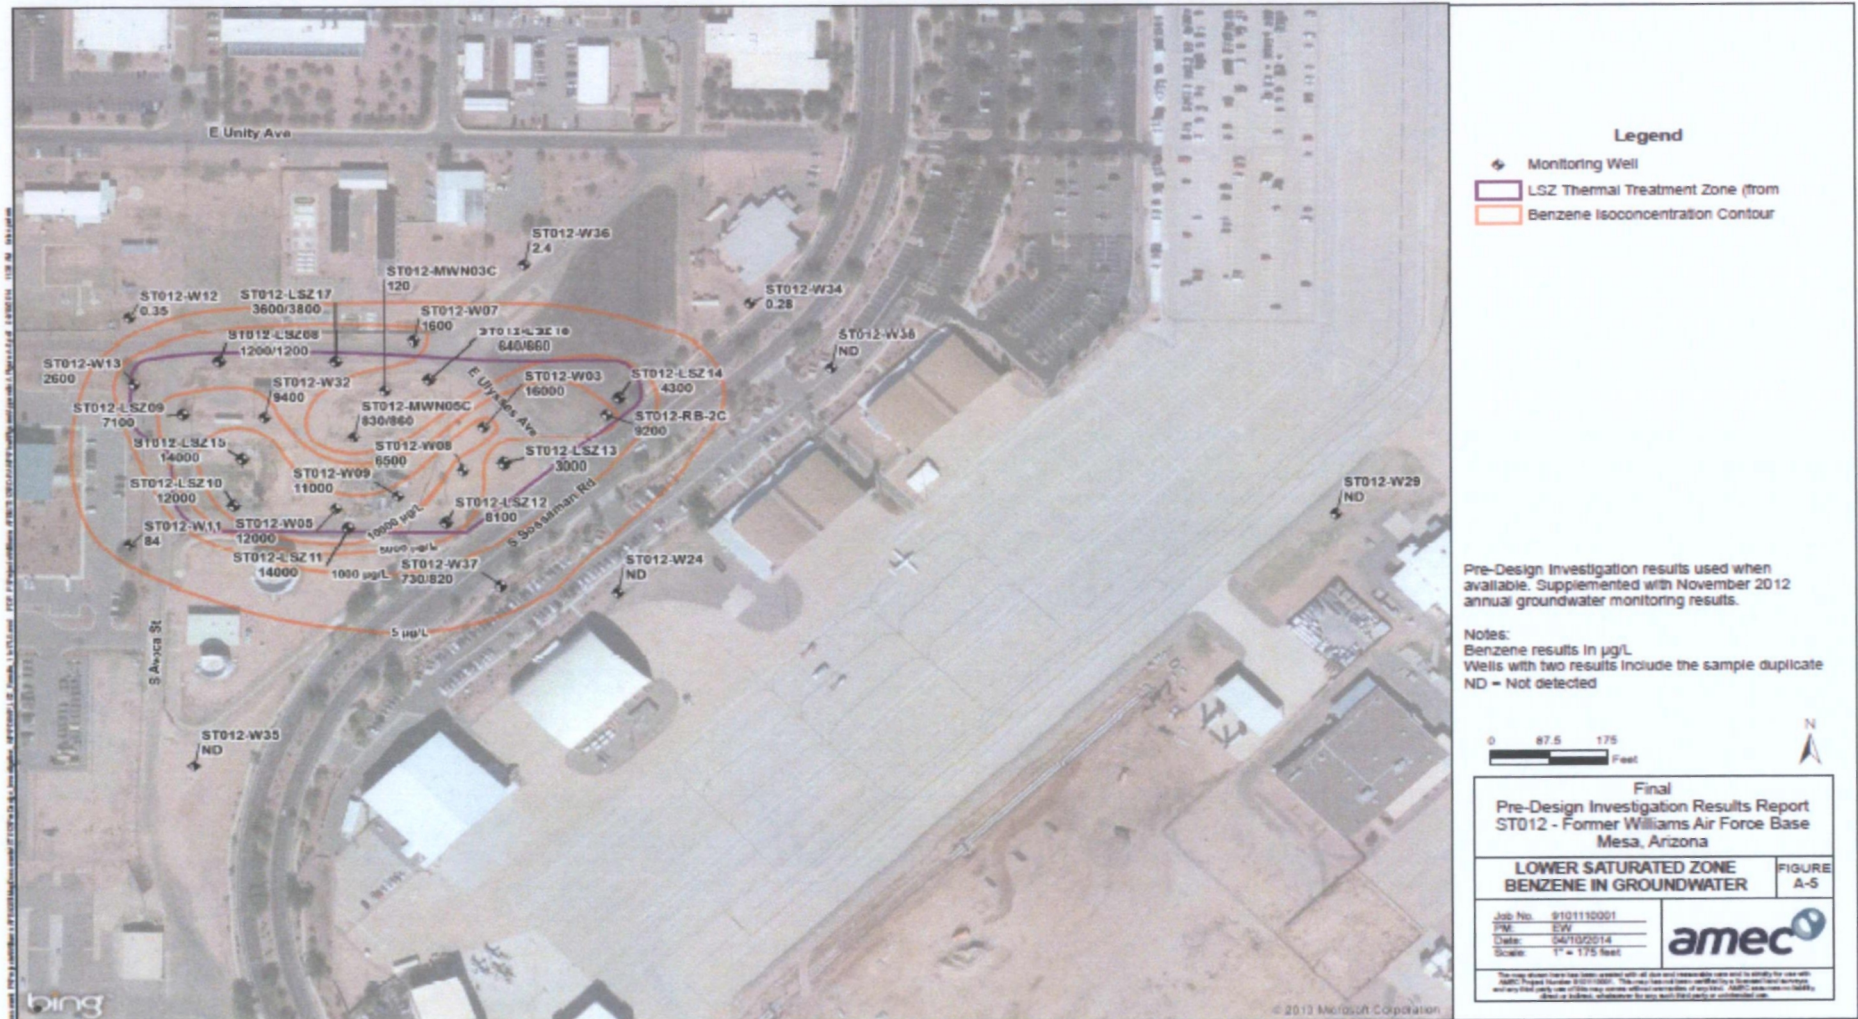
Site ST012 Groundwater Monitoring Update PDI 2014 Benzene Results LSZ

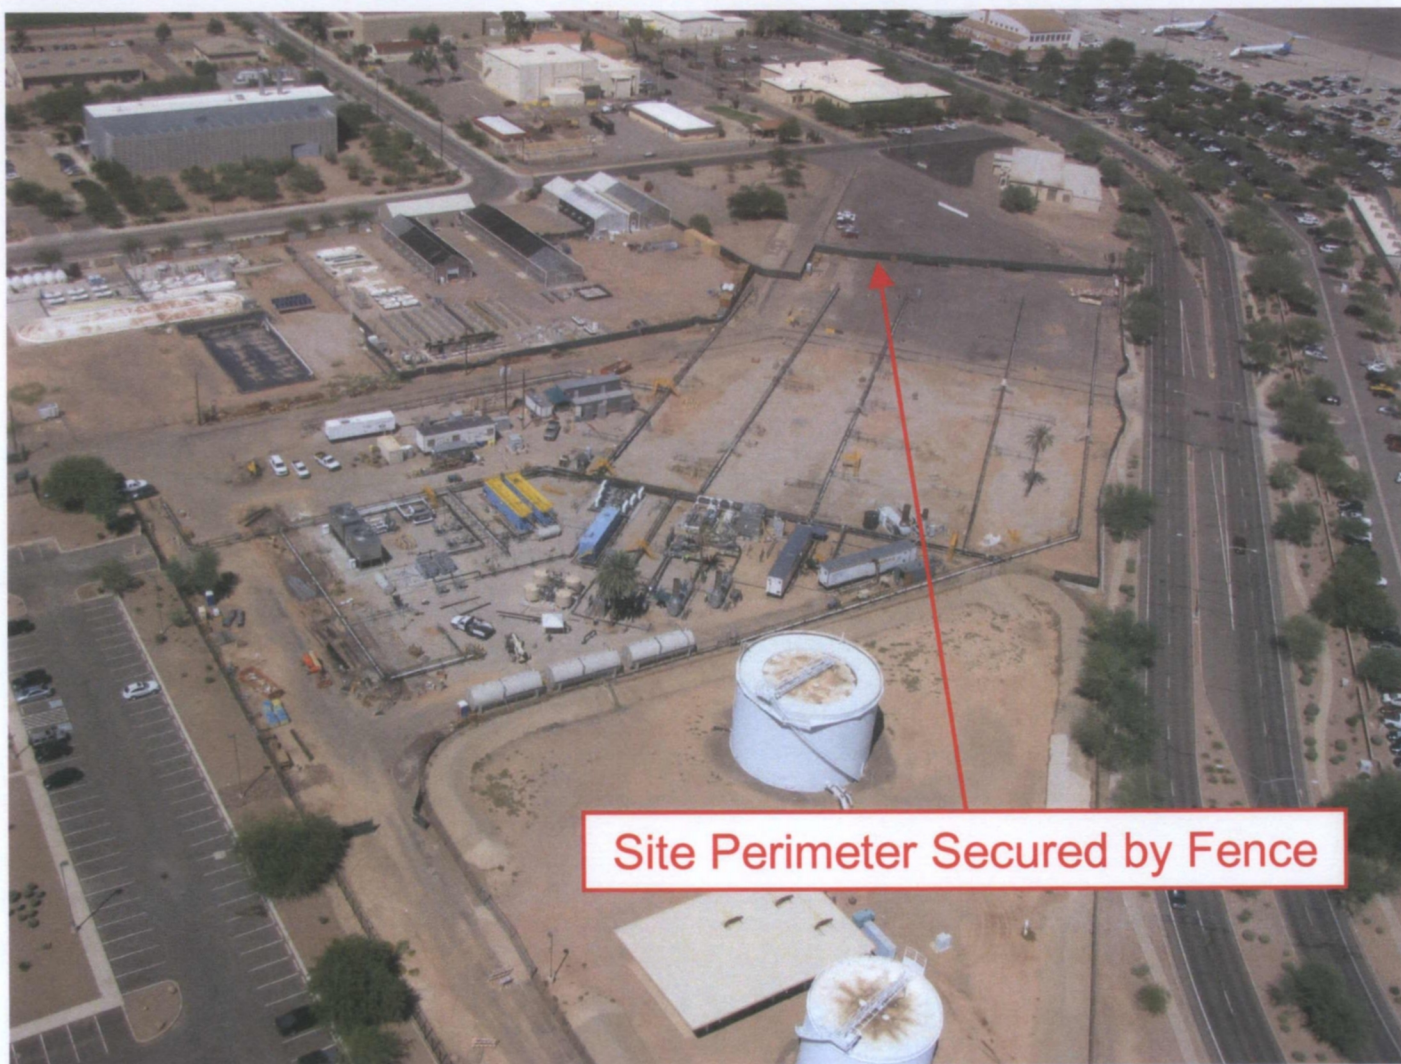
Site Perimeter Secured by Fence

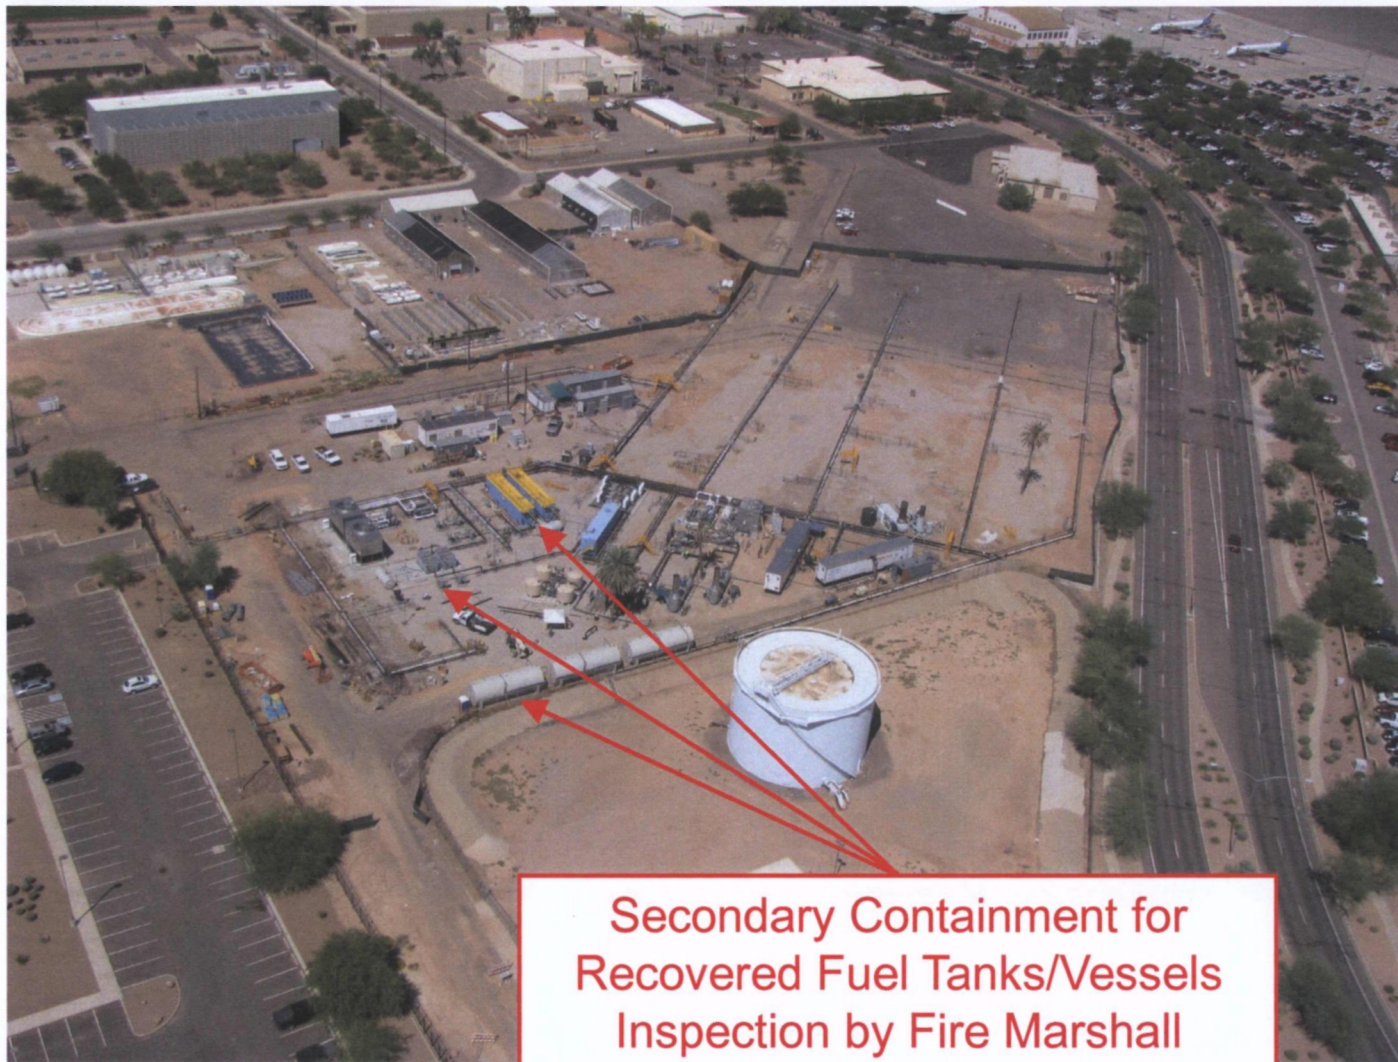
**Secondary Containment for
Recovered Fuel Tanks/Vessels
Inspection by Fire Marshall**

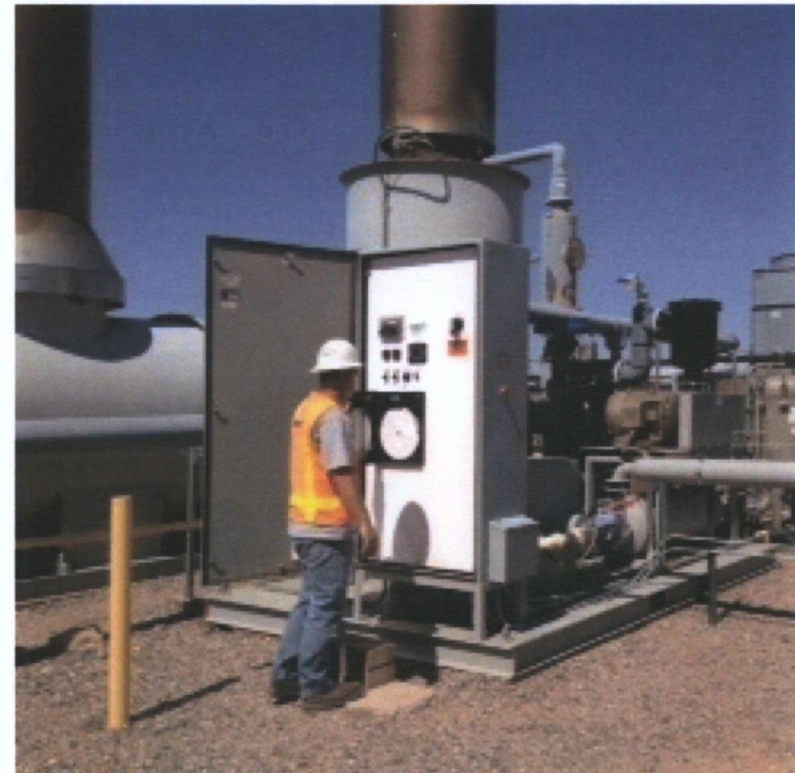
- 72.4% operational uptime
- TPH removed – 55,000 pounds or 8,400 gallons¹ (3,100 gallons in Oct – Dec 2013)

- 91.0% operational uptime
- TPH removed – 14,000 pounds or 2,200 gallons
- 9 of 27 SVE wells operating (same as Oct – Dec 2013)

¹ Confirmation samples taken in Apr-Jun quarter indicate mass removed for Jan-Mar was likely an overestimate
